# AQUA DOC

## The Objective

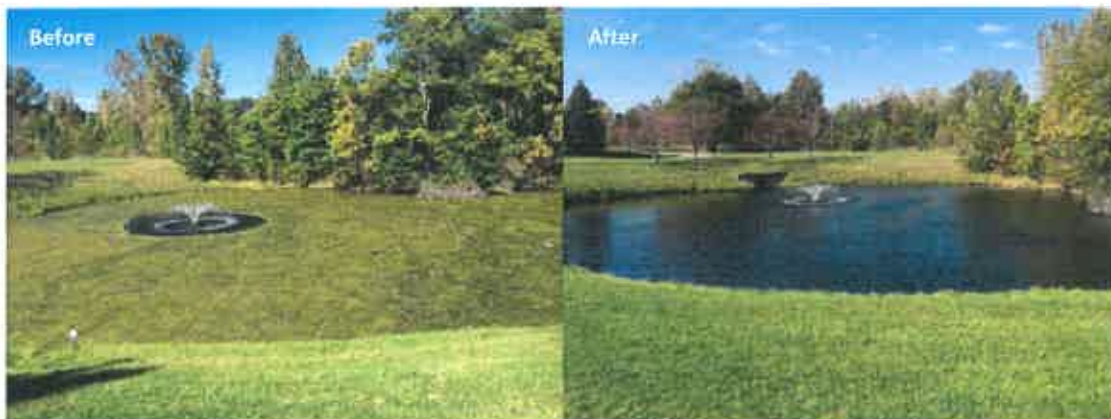
Figures 1 and 2: The state of a portion of the pond before our PondZilla Pro treatment (left) and after treatment (right). It was almost difficult to tell where grass stops and pond begins before treatment!

Working alongside Aquafix, we learned how PondZilla Pro was able to penetrate and kill akinete structures that aid cell regrowth in *Pithophora sp.* We considered that if we were able to attack the akinete we could reduce the reproductive potential of the algae and get ahead of it. Our first application was 5.0 gallons (gal) of PondZilla Pro mixed with 10.0 pounds (lbs) of copper sulfate and 0.5 gal of a non-ionic surfactant. We distributed the products evenly across the pond and throughout the water column. One week later we returned to the site and used 2.0 gal of PondZilla Pro and 1.5 gal of a 9 % chelated copper based algaecide. After only 3 weeks, the pond was completely clear of algae and remained that way for the remainder of the growing season (Figure 2): Ecological balance was restored to this pond and the retired residents have once again been able to enjoy it. Because of the success of PondZilla Pro, it has been implemented as part of the ongoing management strategy for the pond.
