CALOOSA YACHT & RACQUET CLUB

Fort Myers, Florida
2017

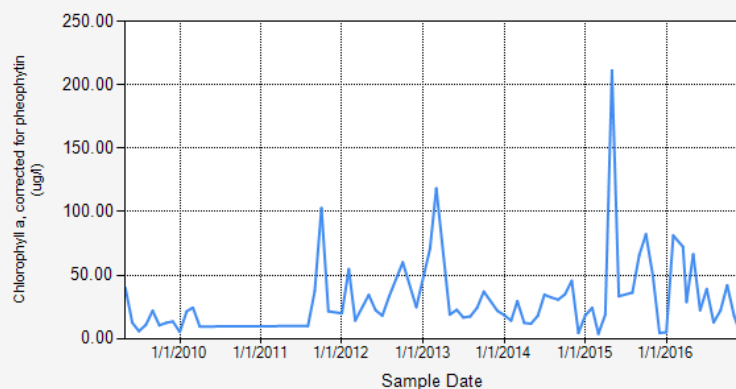
**Chlorophyll a, corrected for pheophytin
Caloosa Yacht
(81 measurements)**

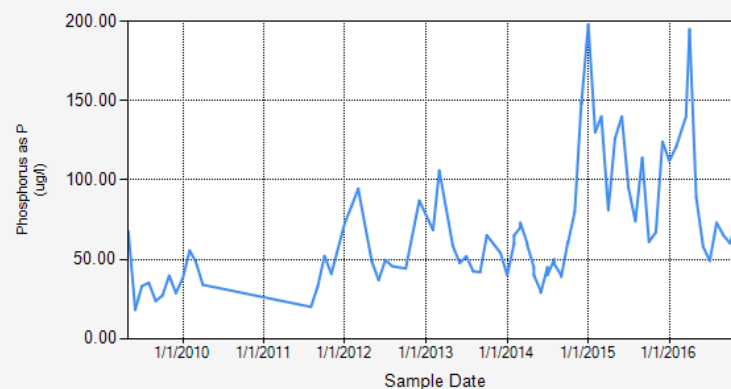
**Phosphorus as P
Caloosa Yacht
(82 measurements)**

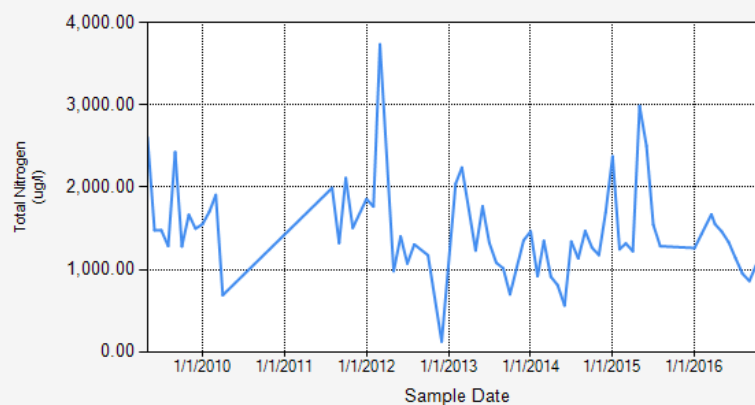
**Total Nitrogen
Caloosa Yacht
(66 measurements)**

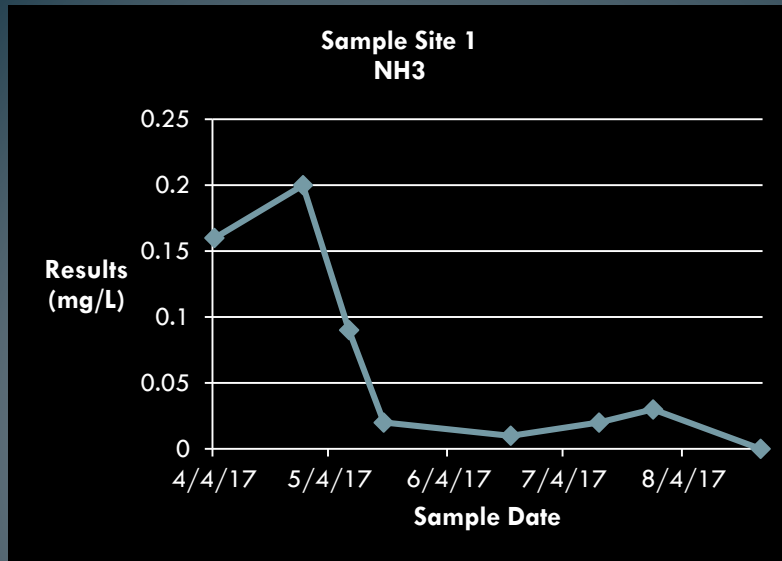
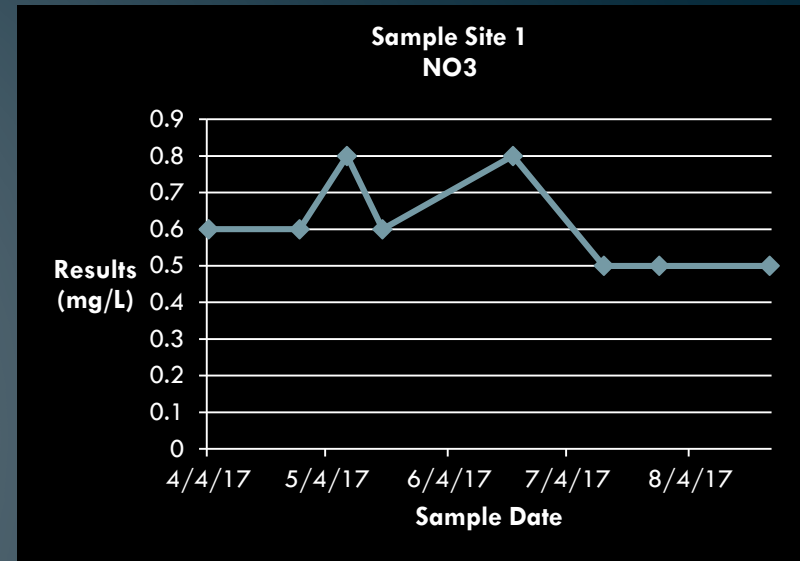
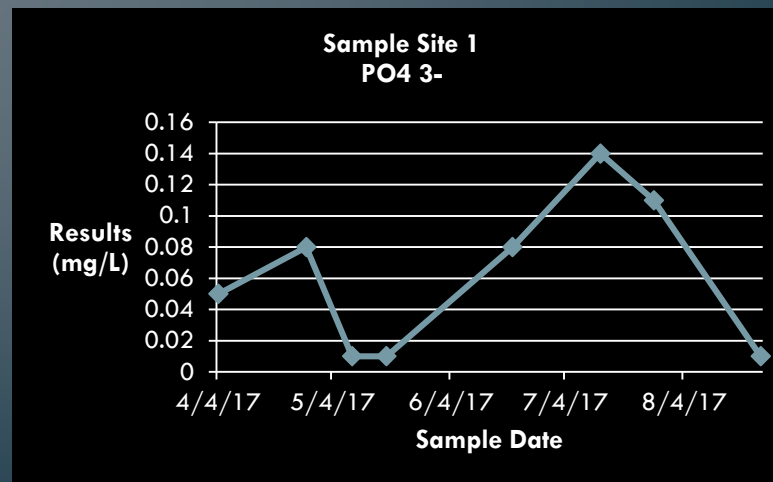
APPENDIX: LEVELS AFTER TREATMENTS AT SAMPLE SITE 1

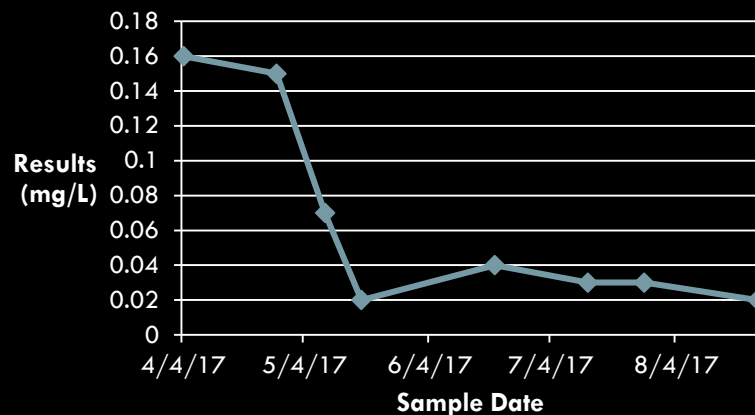
Sample Site 2
NH3

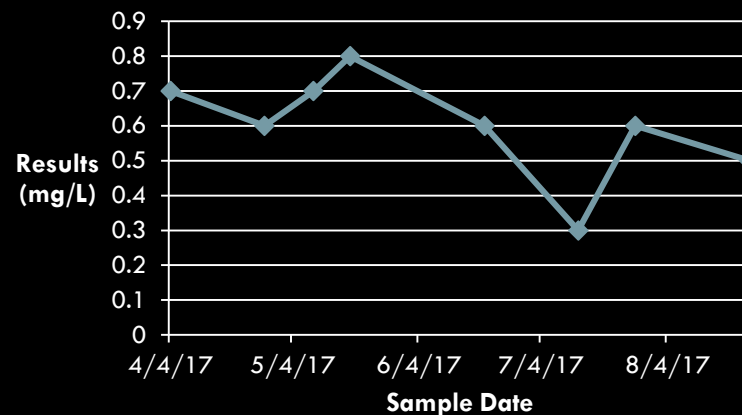
Sample Site 2
NO3

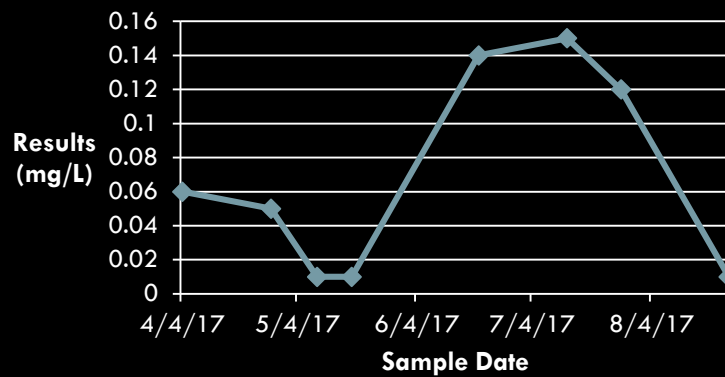
Sample Site 2
PO4 3-

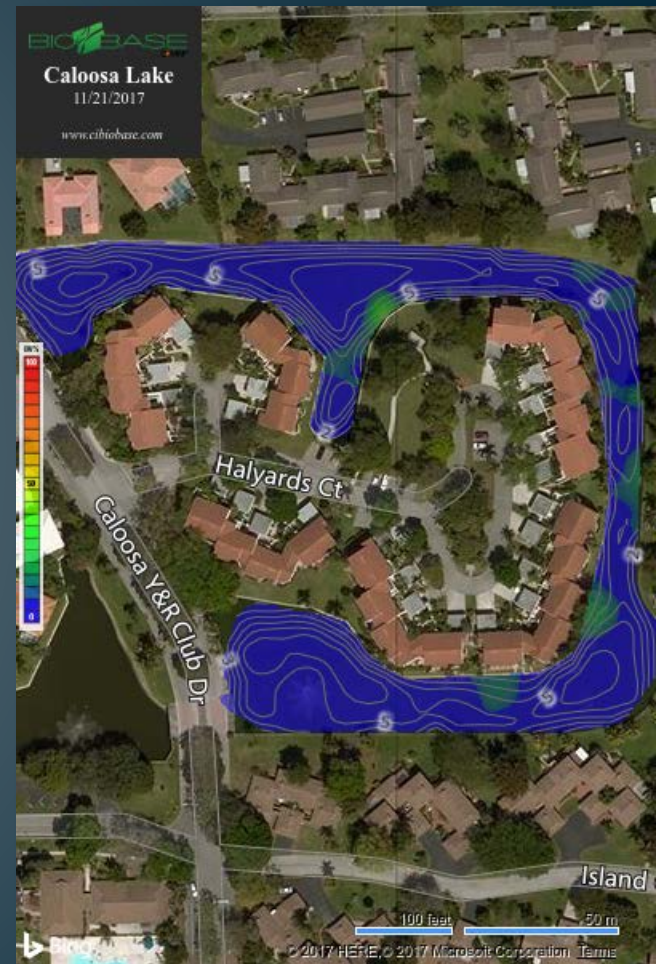
Vegetation Heat Map
