How does your bottom look?

A pictographic analysis of pond sludge reduction and its effect on aquatic vegetative growth.

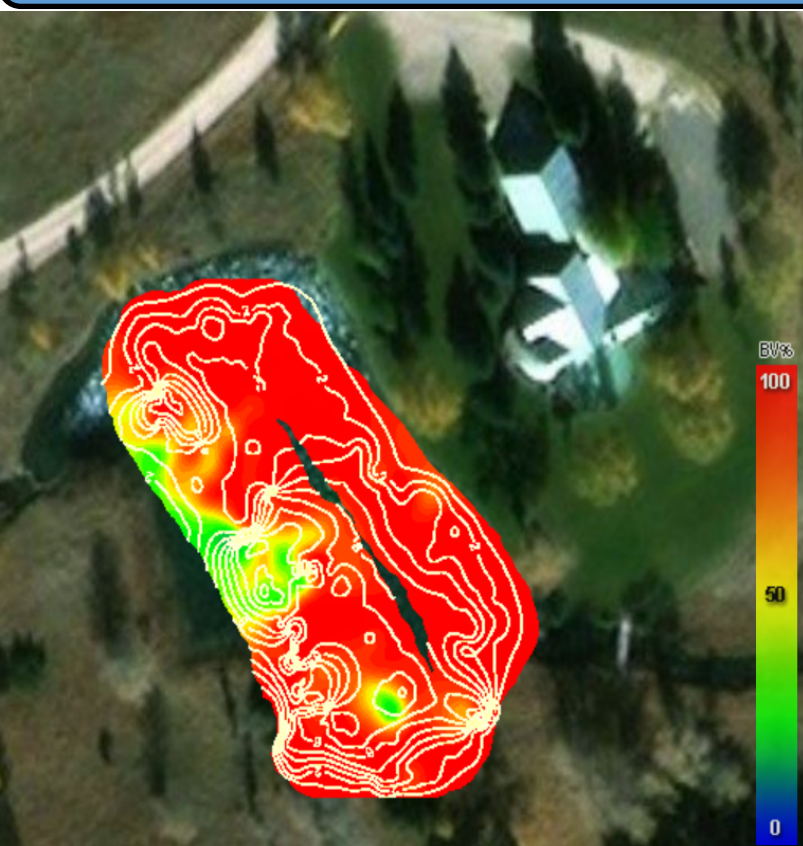
Chateau Pond Bio Volume Essay May 2017 Pre—application

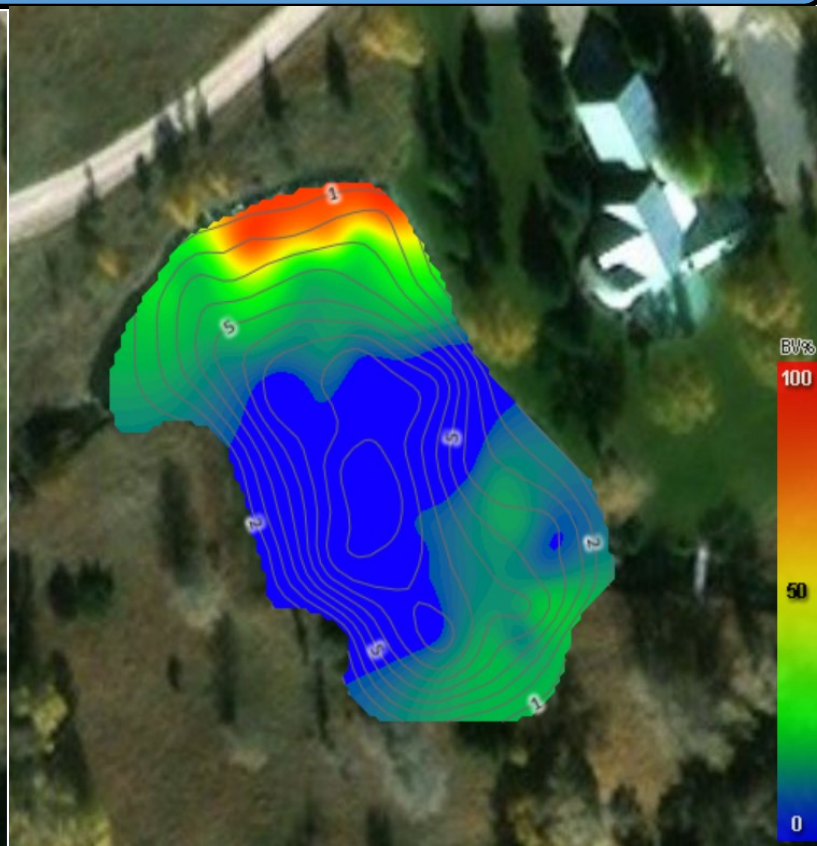
Chateau Pond Bio Volume Essay June 2018 Post applications

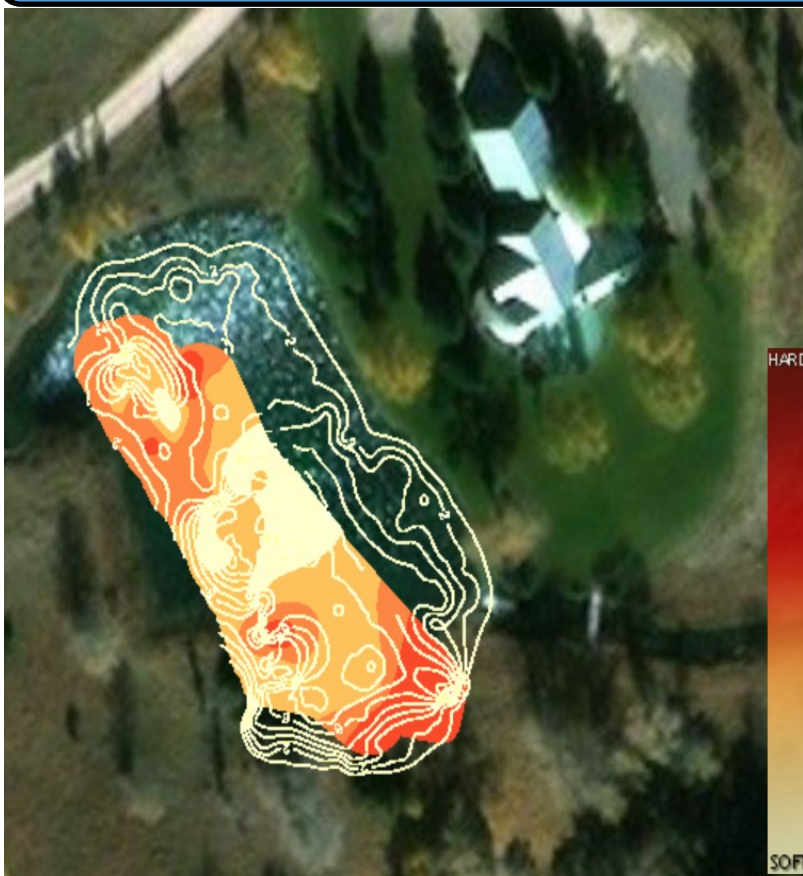
Chateau Pond Bottom Composition May 2017

* Analysis incomplete due to vegetative overgrowth

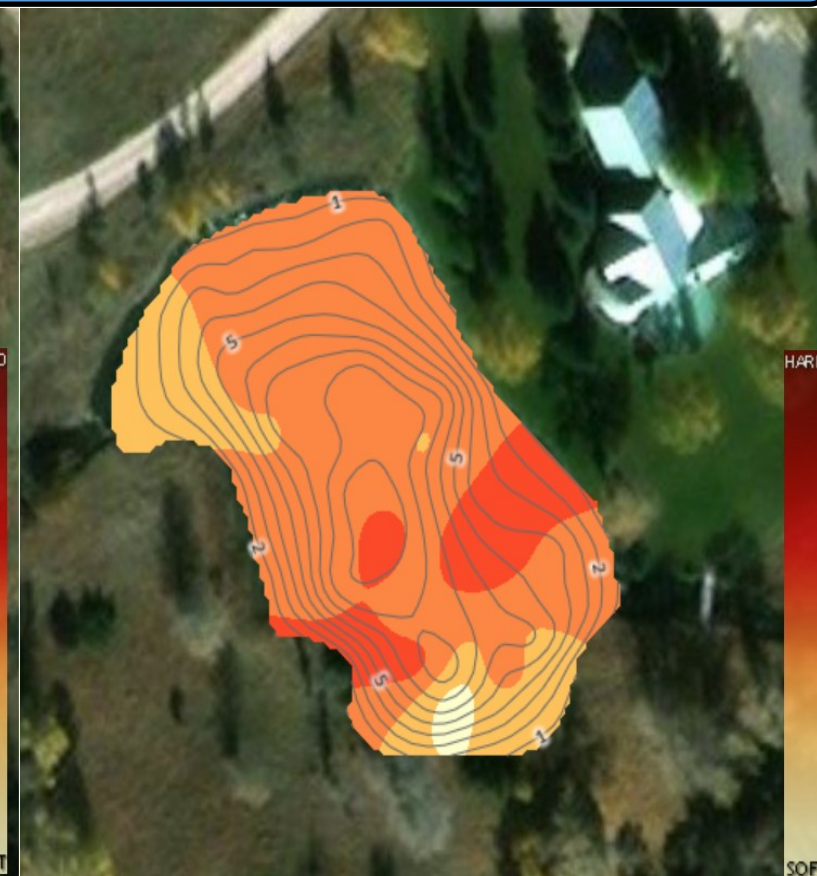
Chateau Pond Bottom Composition June 2018

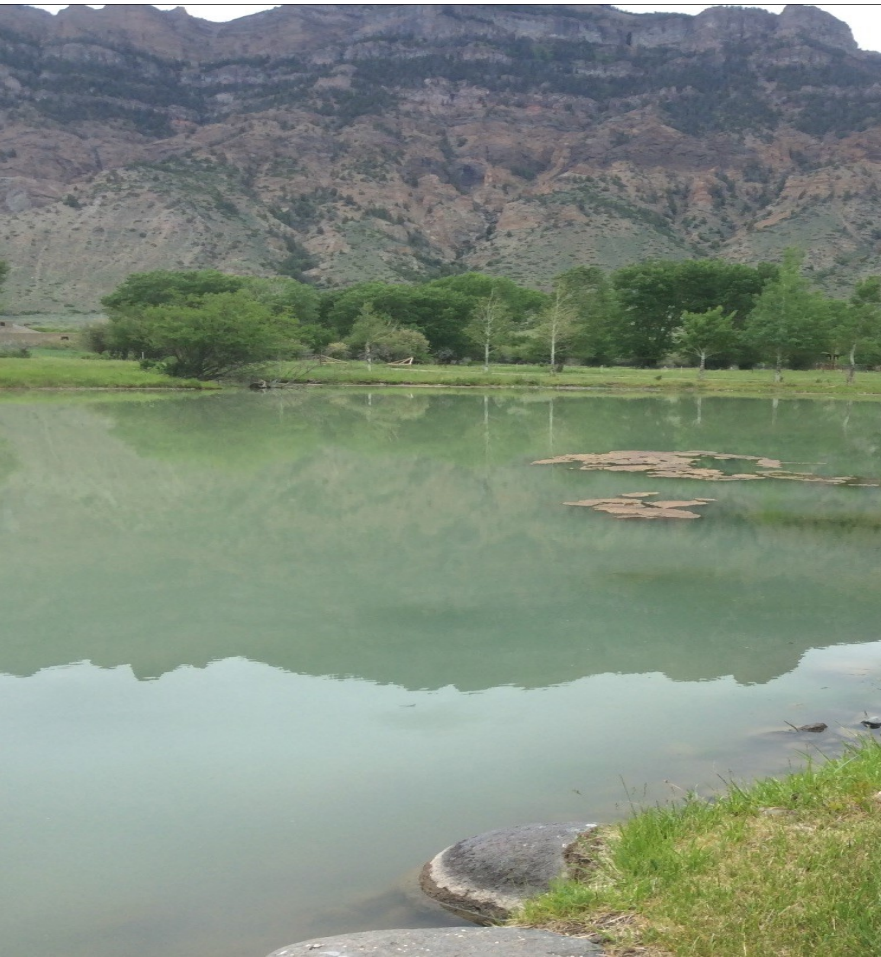
Chateau Pond
Pre
Treatment
May 2017

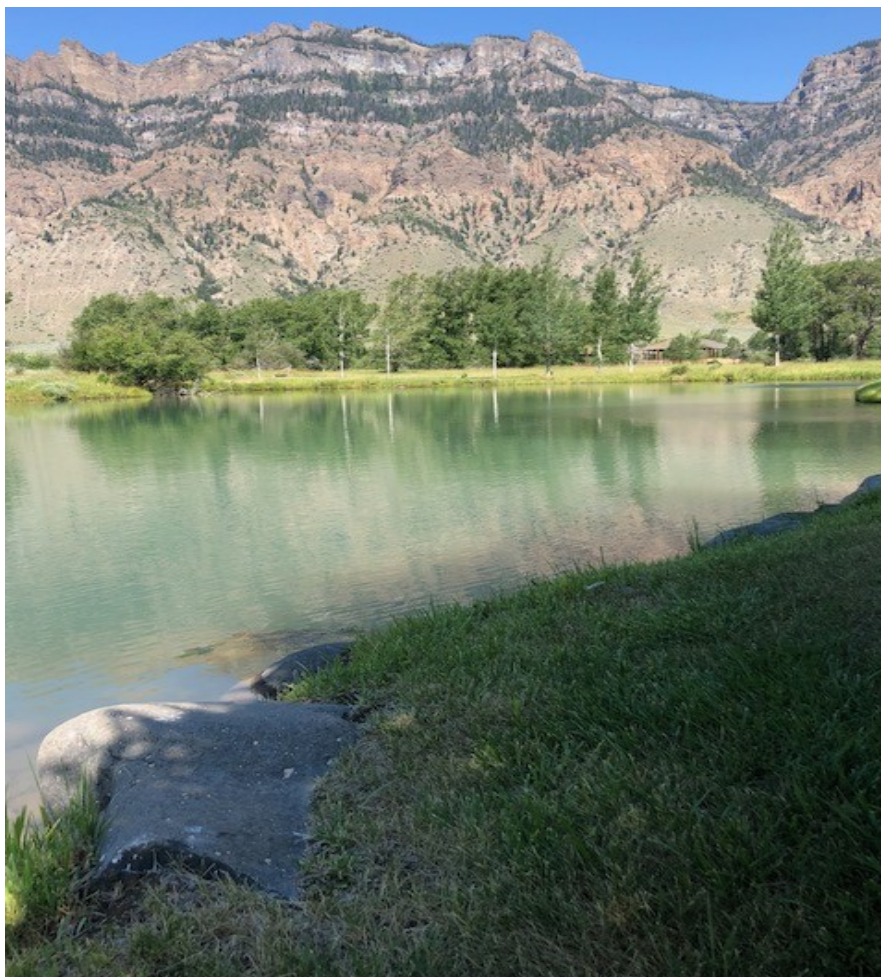
Chateau
Pond
Post Treat-
ment

July 2018

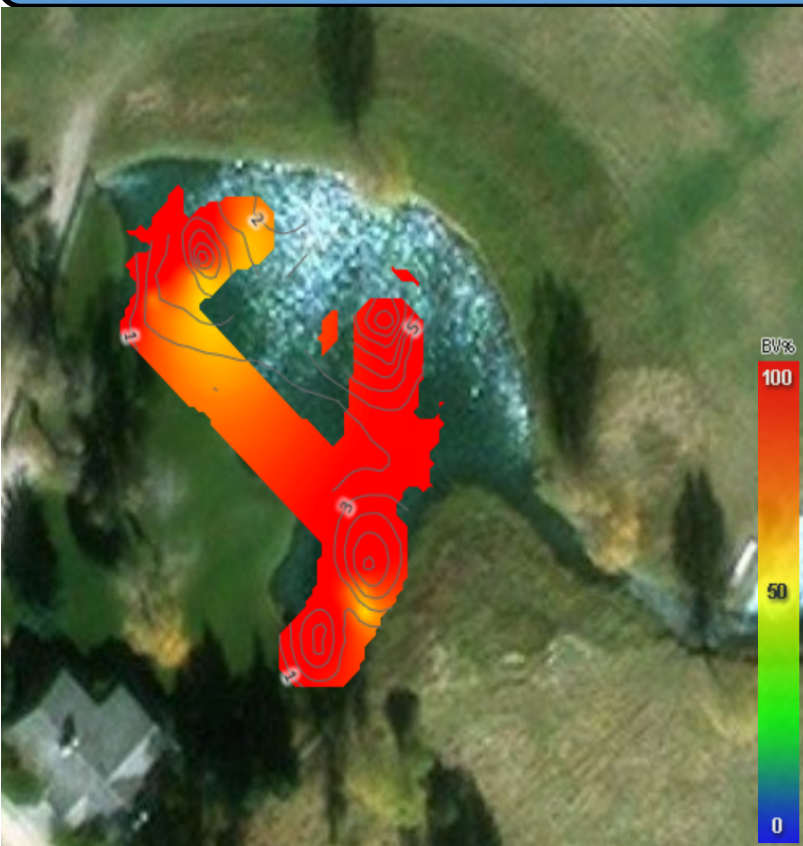
Lodge Pond Bio Volume Essay May 2017 Pre—application
*Analysis incomplete due to aquatic vegetation

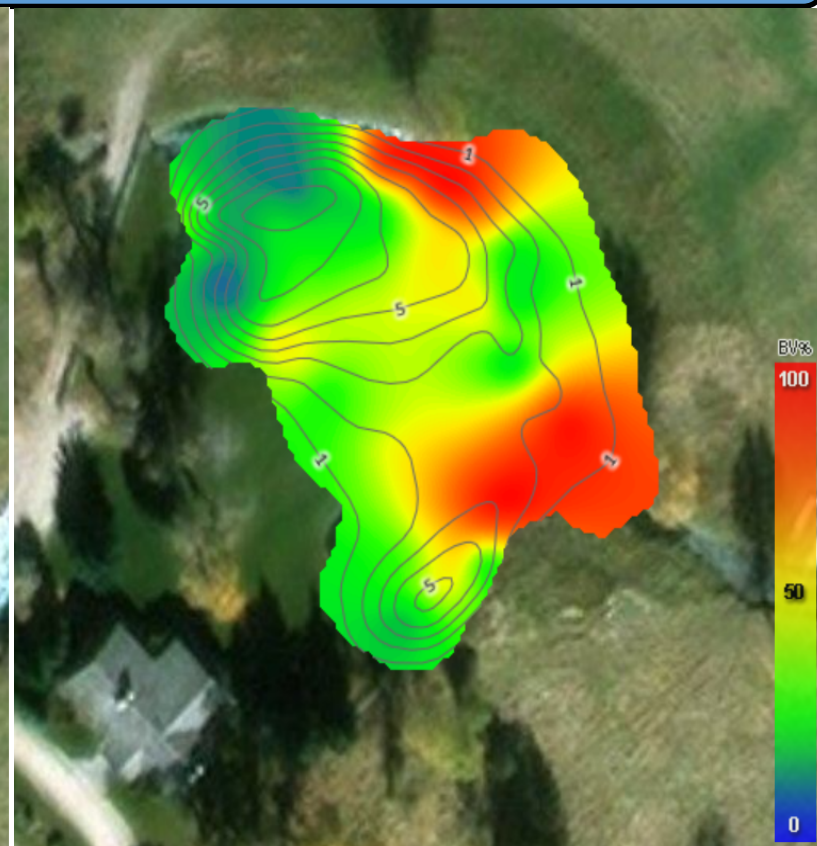
Lodge Pond Bio Volume Essay June 2018 Post applications

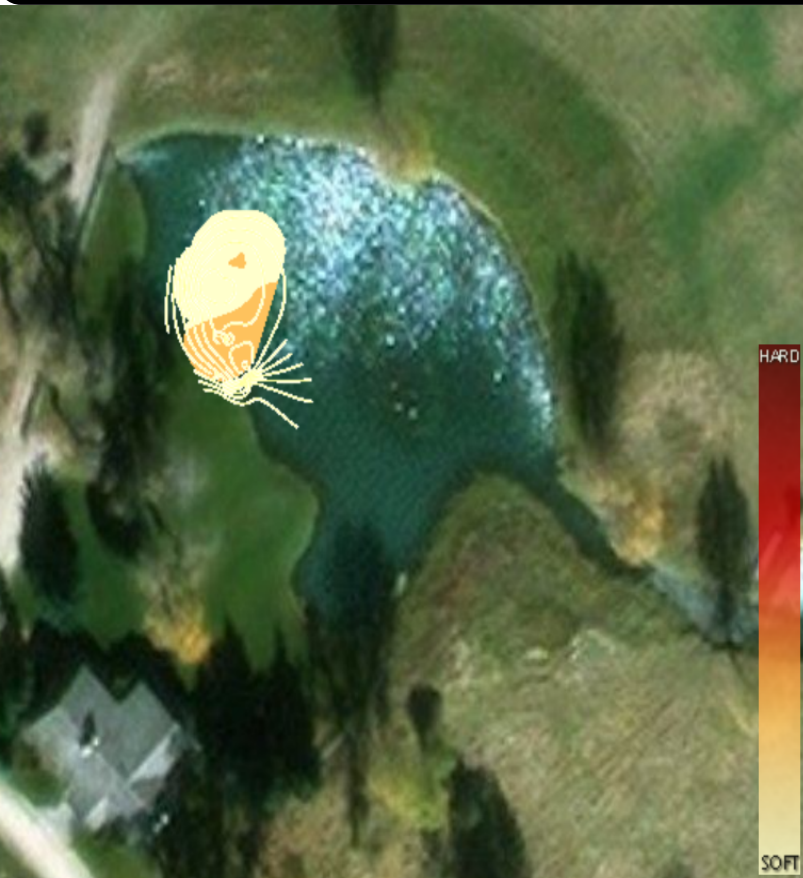
Lodge Pond Bottom Composition May 2017
*Analysis incomplete due to aquatic vegetation

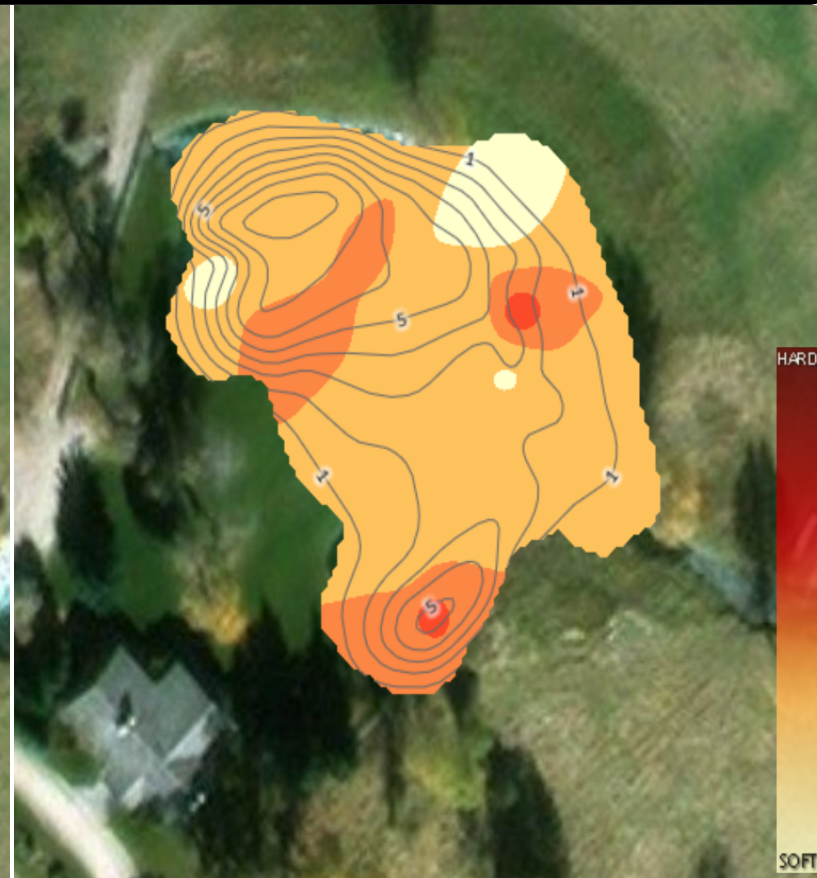
Lodge Pond Bottom Composition June 2018

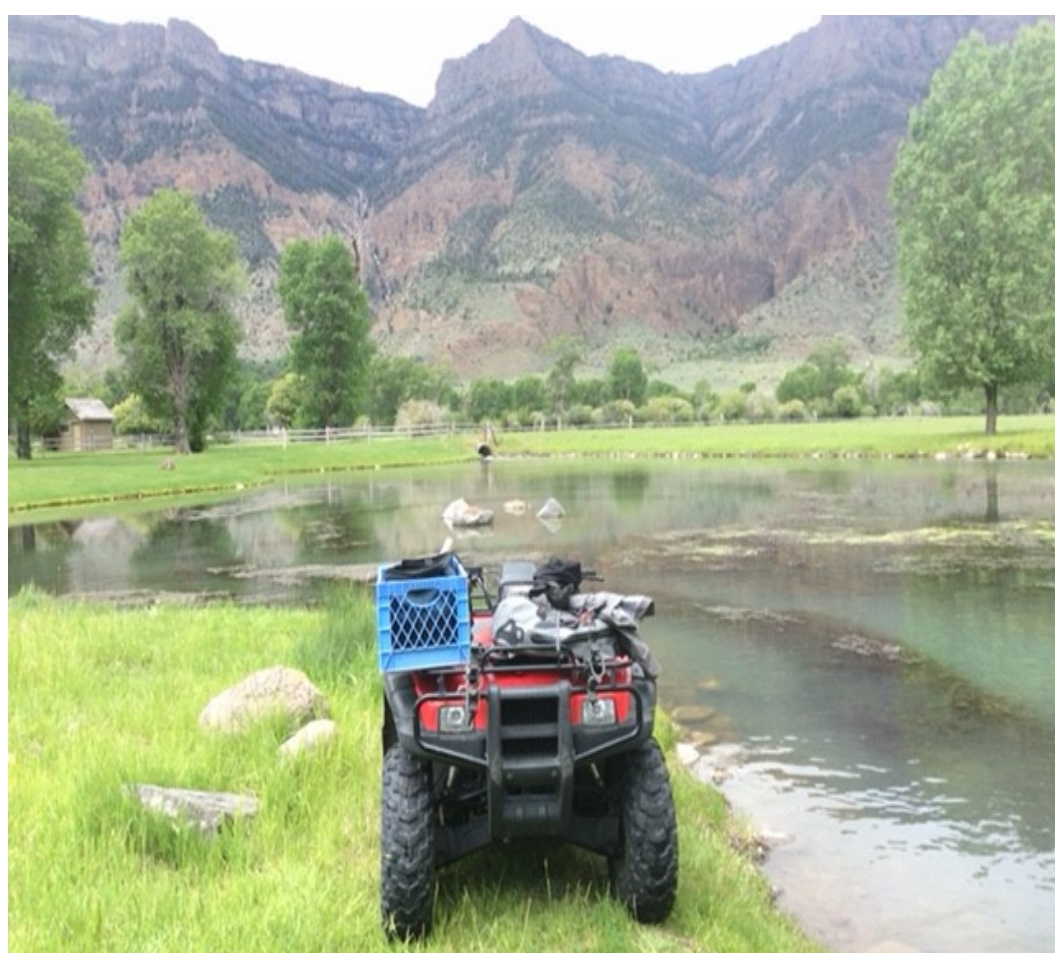
Lodge Pond May 2017 Pre Treatment Photo

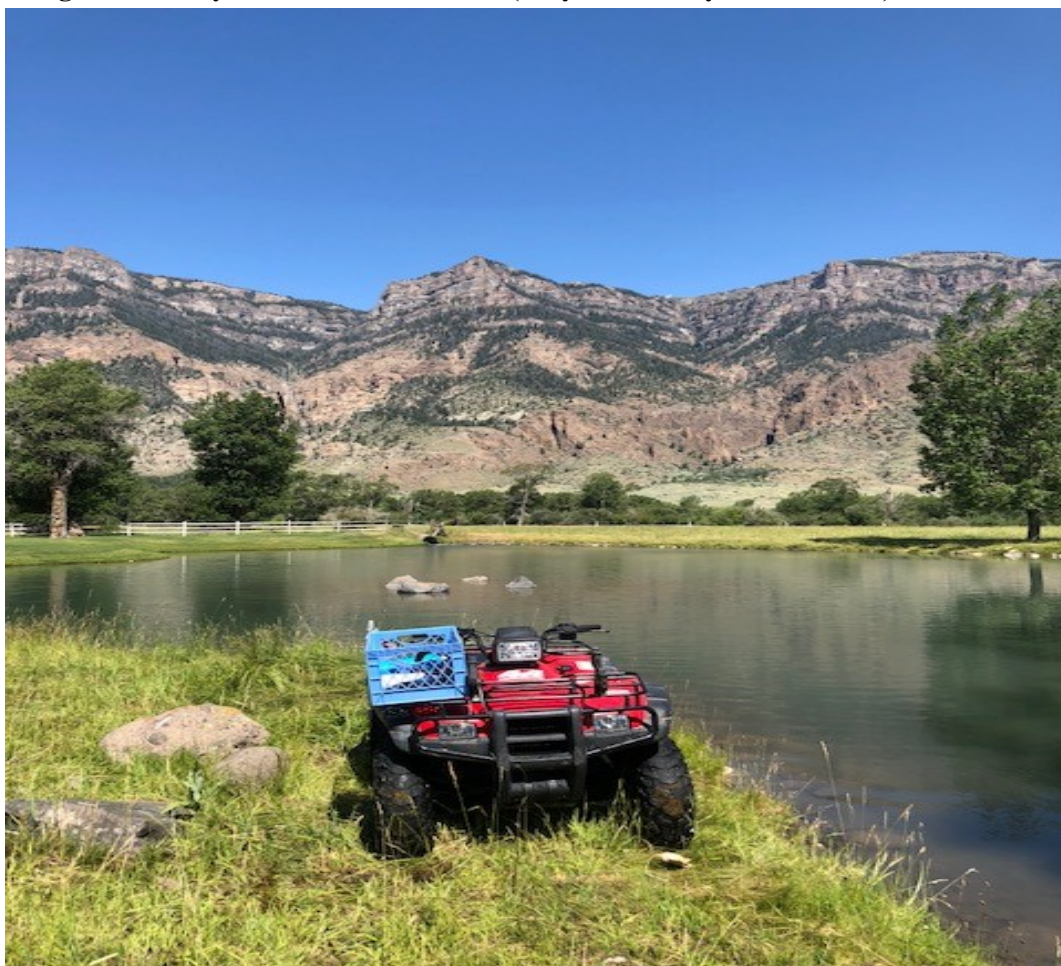
Lodge Pond July 2018 Post Treatment (May, June, July 2017 & 2018)

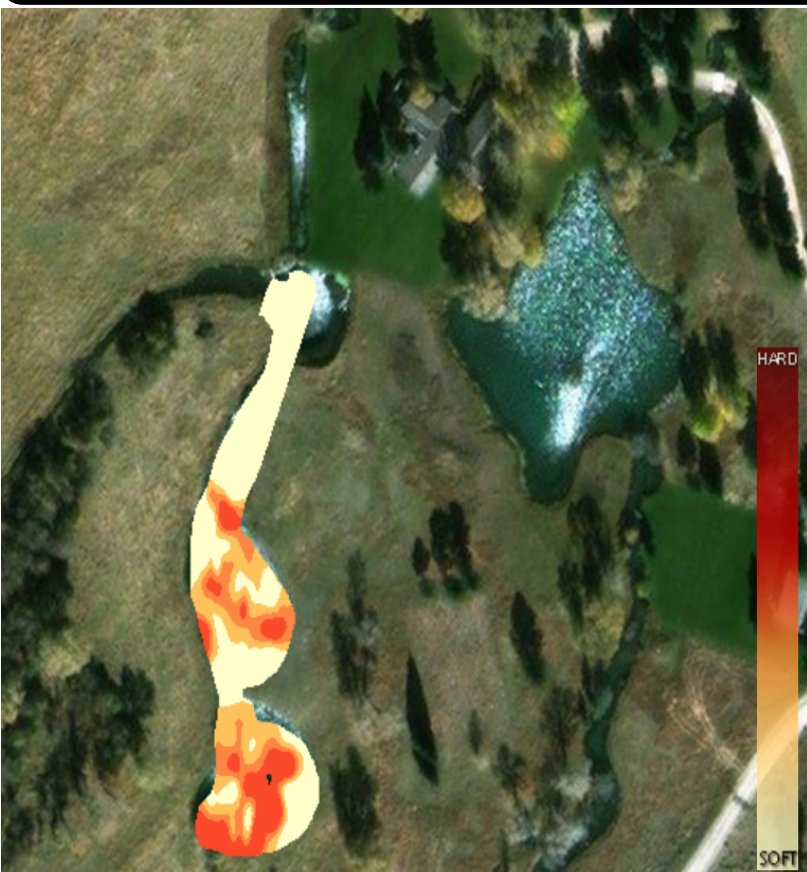
Twins Pond Bottom Composition May 2017

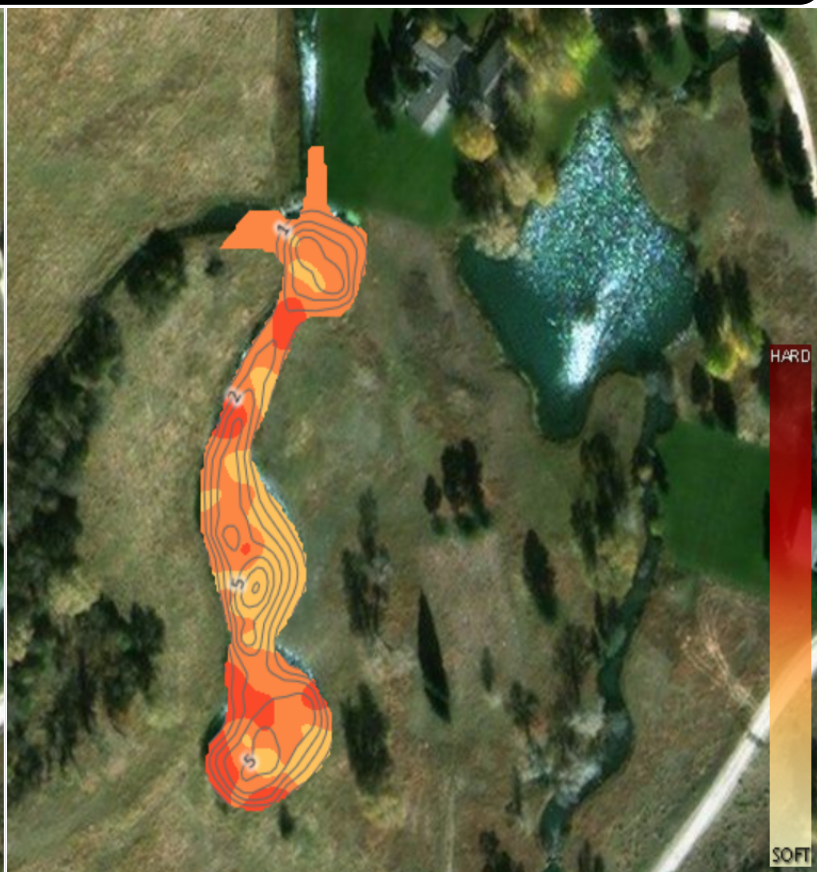
Twins Pond Bottom Composition June 2018

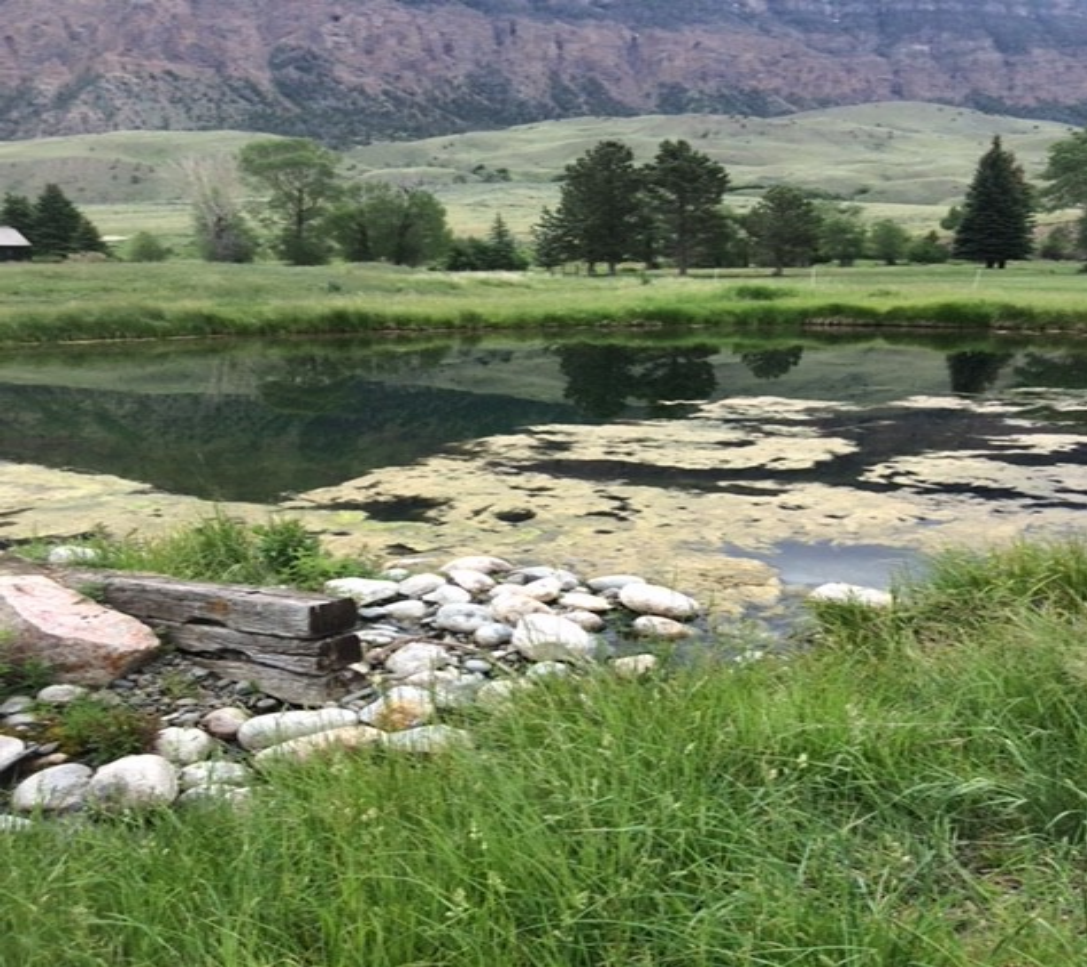
Twins Ponds May 2017 Pre Treatment Photo

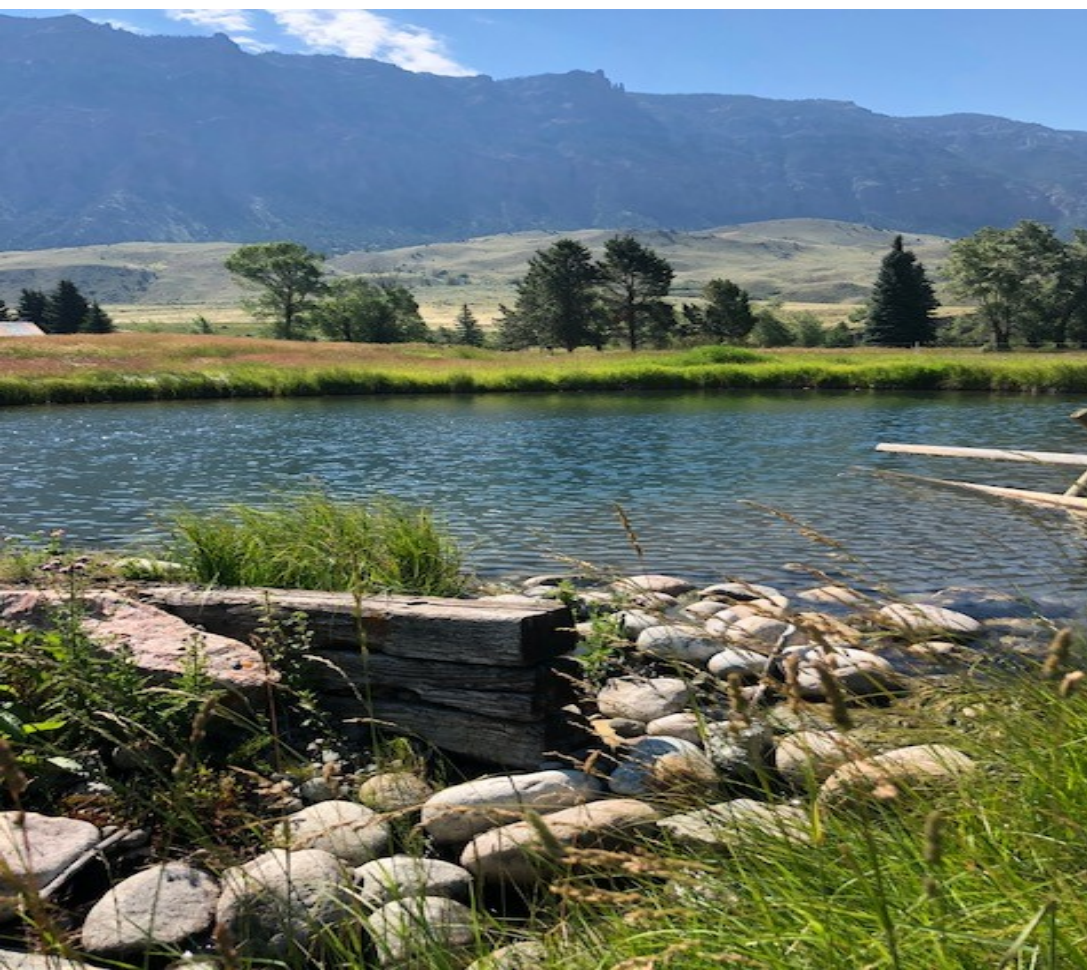
Twins Ponds July 2018 Post Treatment (May, June, July 2017 & 2018)

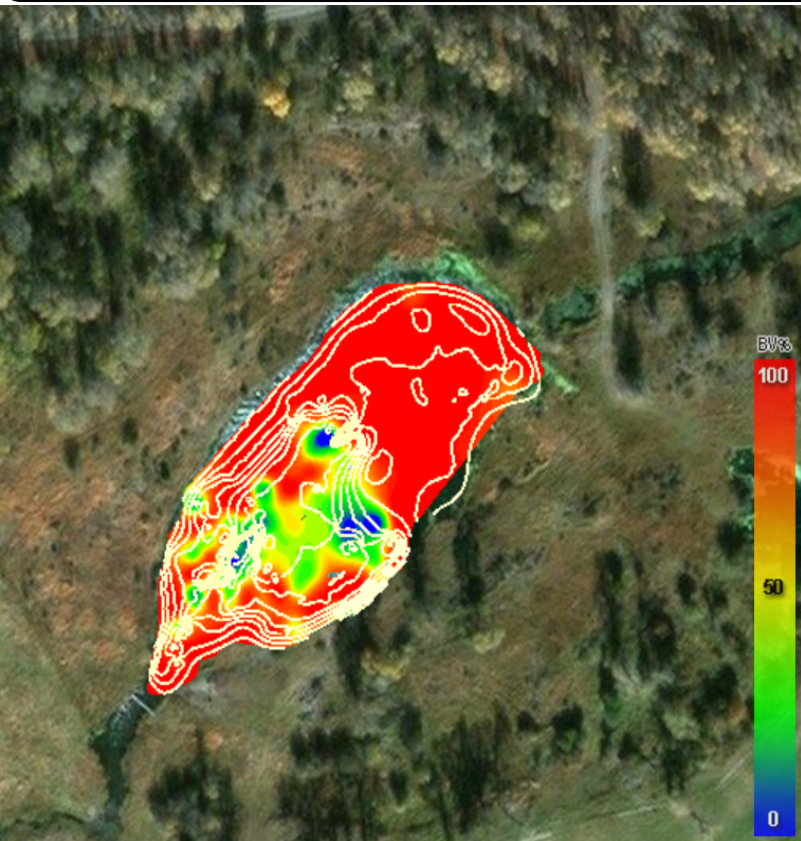
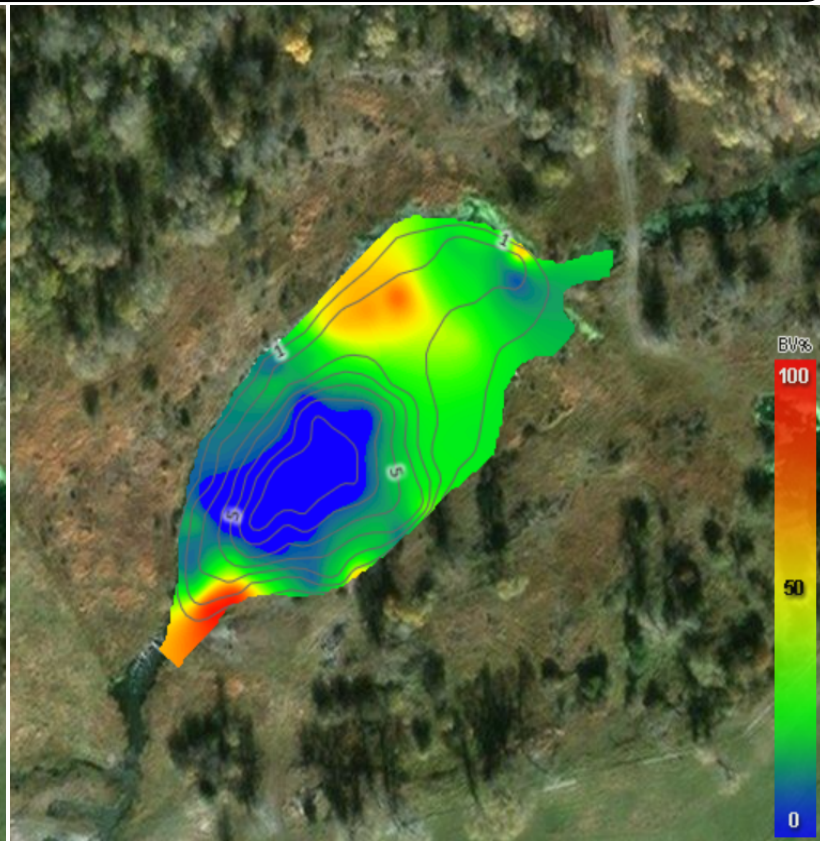
Waterfowl Pond Bio Volume Essay May 2017 Pre application Waterfowl Pond Bio Volume Essay June 2018 Post App

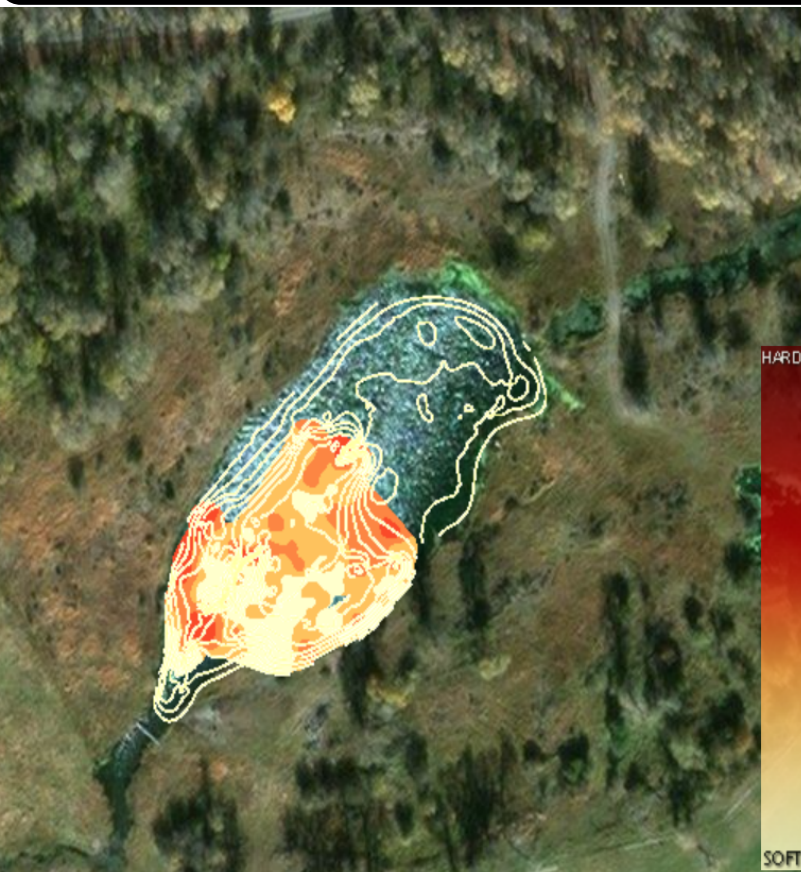
Waterfowl Pond Bottom Composition May 2017

*Analysis incomplete due to aquatic vegetation

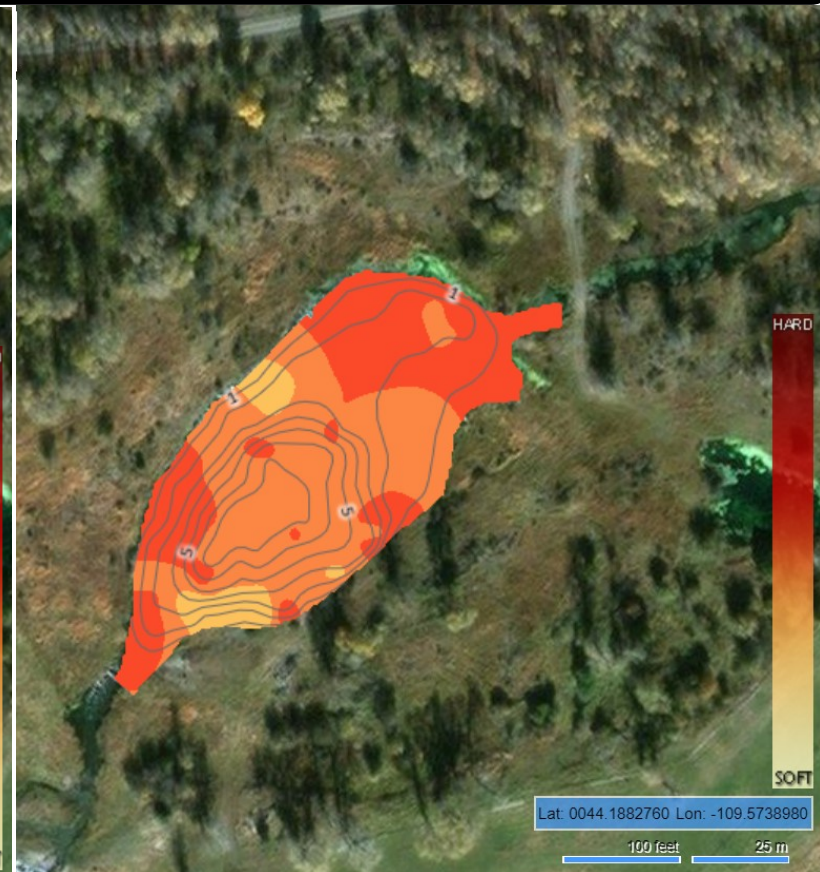
Waterfowl Pond Bottom Composition June 2018

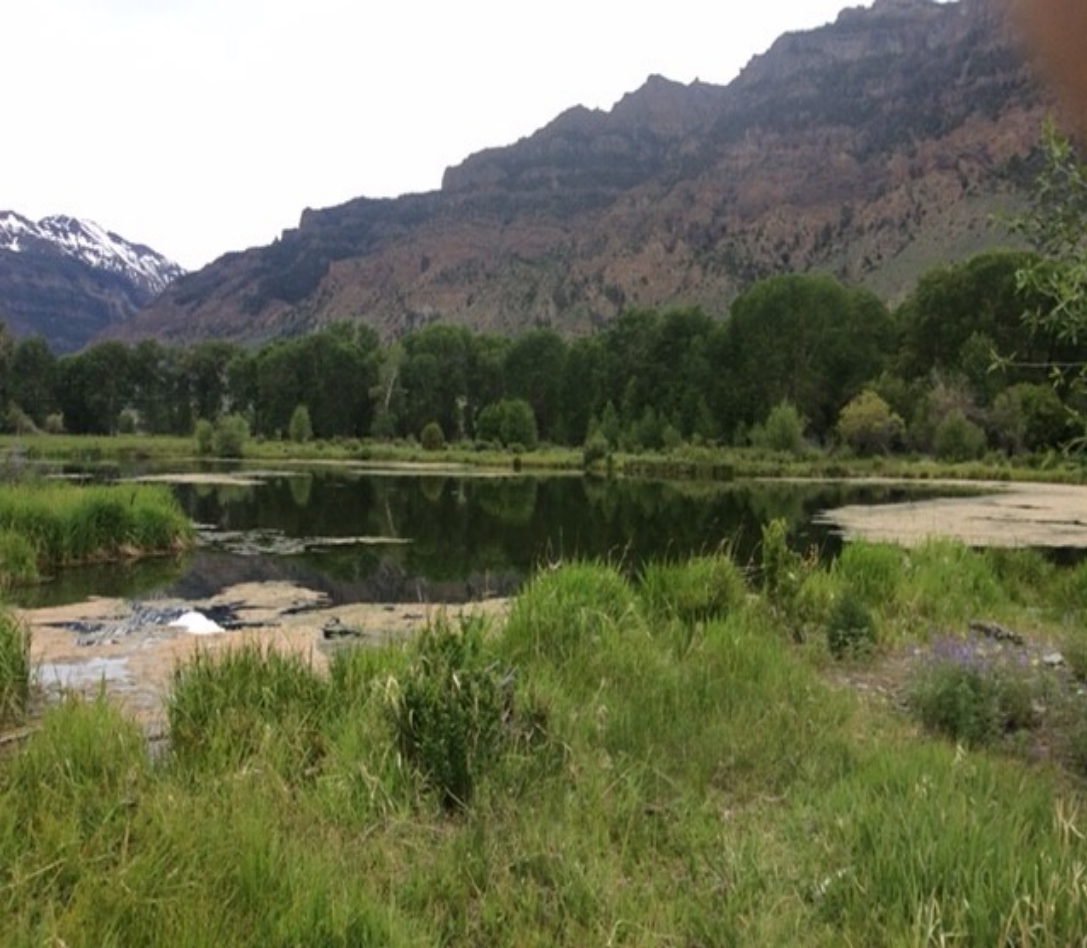
Waterfowl Pond May 2017 Pre Treatment Photo

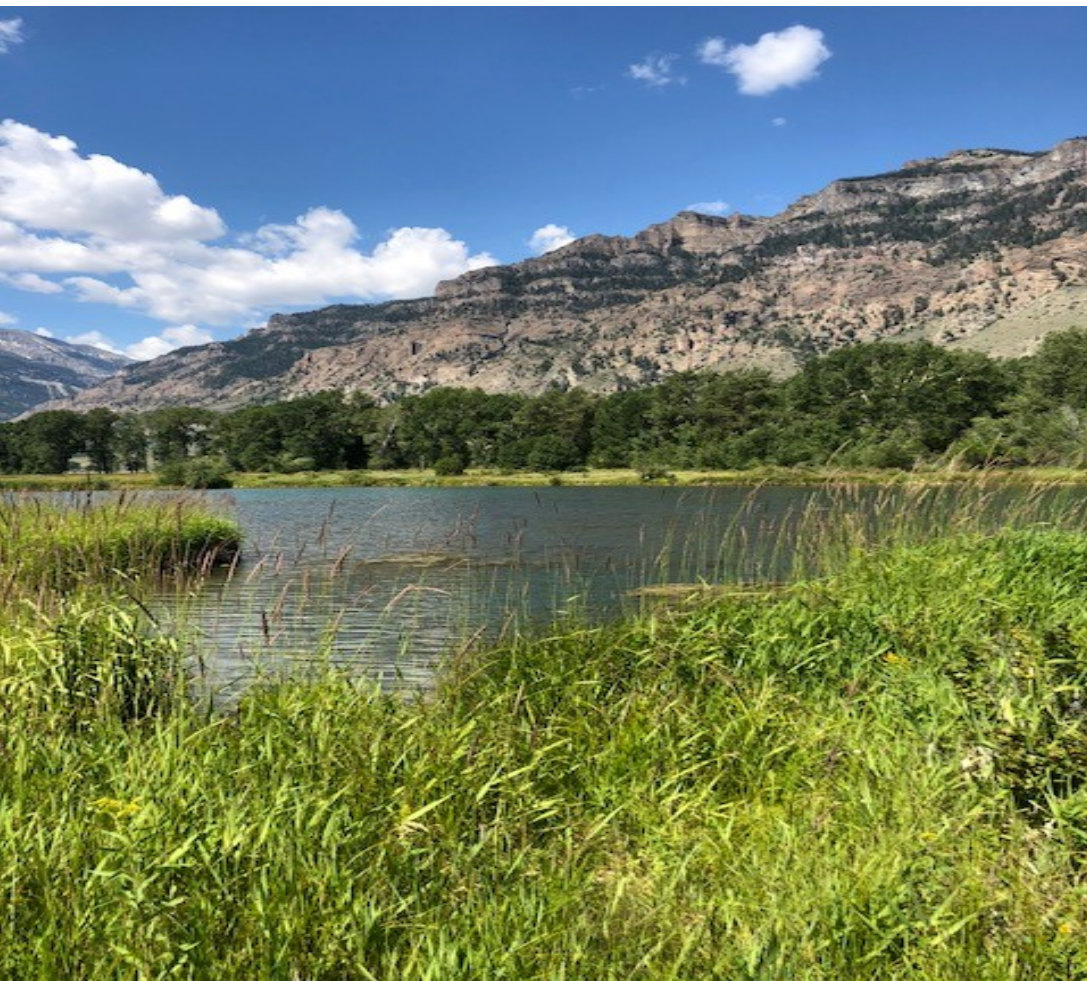
Waterfowl Pond July 2018 Post Treatment (May, June, July 2017 & 2018)
