Analysis of Pithophora Reduction Utilizing PondZilla Pro and Nature's Blend Probiotic

By: Kayla Chancellor

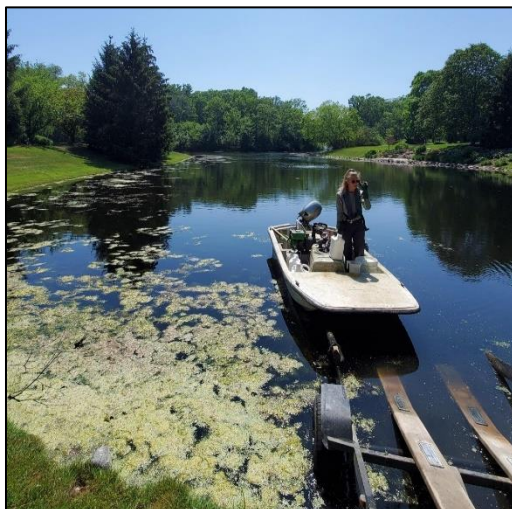
Introduction: A 1.5 acre, private pond located in Lake Forest, Illinois had dense Pithophora growth starting in mid-May. This region in northeastern Illinois has very hard water; therefore, copper treatments are less effective. For years, I have struggled to gain control of the algae with copper/diquat treatments. The algae would brown out and die but remain on the surface of the water, causing more algae growth, and the cycle would just continue month after month. This year, I was determined to have success.

Treatment: On June 22, I did a very aggressive algae treatment. I did a tank mix of Copper Sulfate, Diquat, and 2.5 gallons of PondZilla Pro. I did a subsurface treatment to allow for maximum algal penetration. I also added 4 pounds of Nature's Blend post treatment. 14 total pounds of Nature's Blend were applied throughout the course of 5 months (May-September).

Results: I checked back up on the pond 7 days post treatment. To my pleasant surprise I saw a major improvement. Algae levels had decreased by 10% in just one week. I serviced the pond 14 days post treatment, and the algae was almost completely gone. For the remainder of the season the algae levels remained low and very manageable.

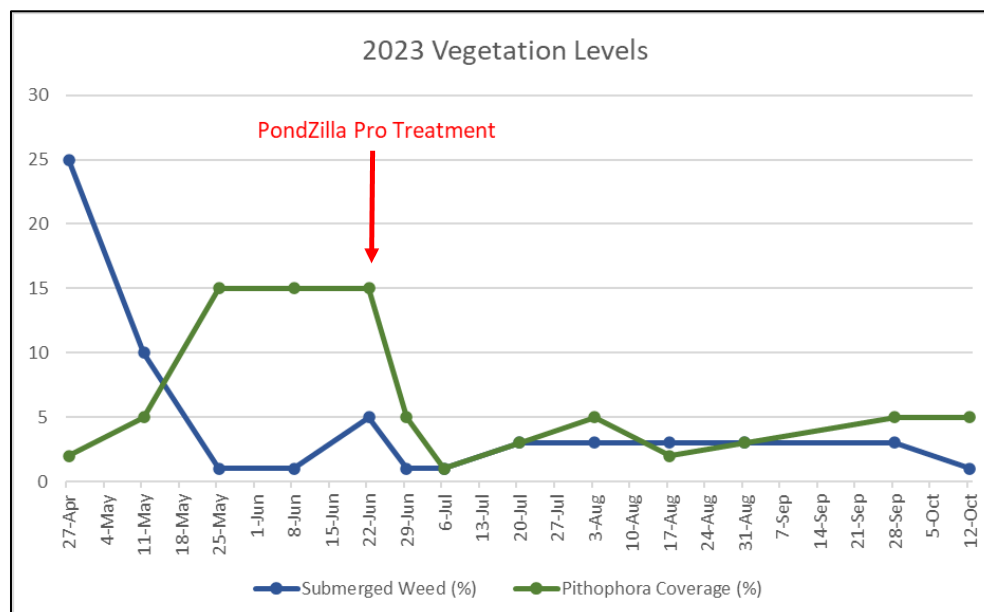
2023 Data Summary			
Service Date	Submerged Weed (%)	Pithophora Coverage (%)	Water Temperature (°F)
27-Apr	25	2	58.0
11-May	10	5	66.7
25-May	1	15	65.7
8-Jun	1	15	68.8
22-Jun	5	15	71.9
29-Jun	1	5	72.7
6-Jul	1	1	74.6
20-Jul	3	3	76.0
3-Aug	3	5	72.0
17-Aug	3	2	73.4
31-Aug	3	3	68.9
28-Sep	3	5	65.0
12-Oct	1	5	58.6
Average	4.62	6.23	68.64
High	25	15.0	76.0
Low	1	1.0	58.0
