# **Pondzilla Floating Tape Grass Experiment** Colin Lewis, Lee County Hyacinth Control District

#### **Introduction** Species: Valisenaria americana

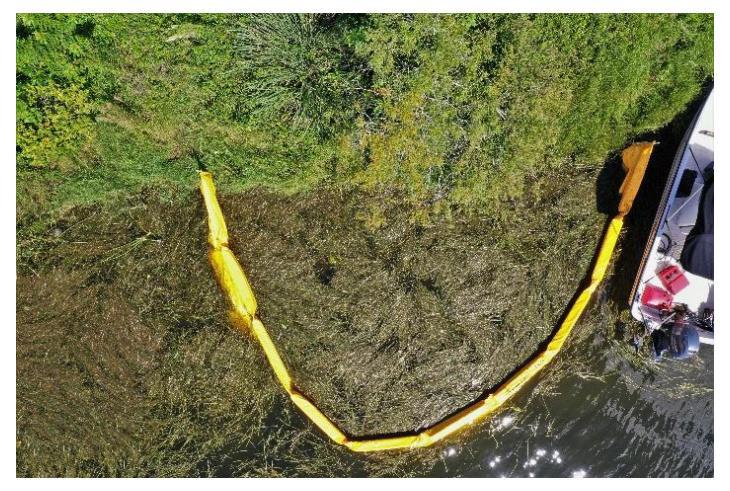
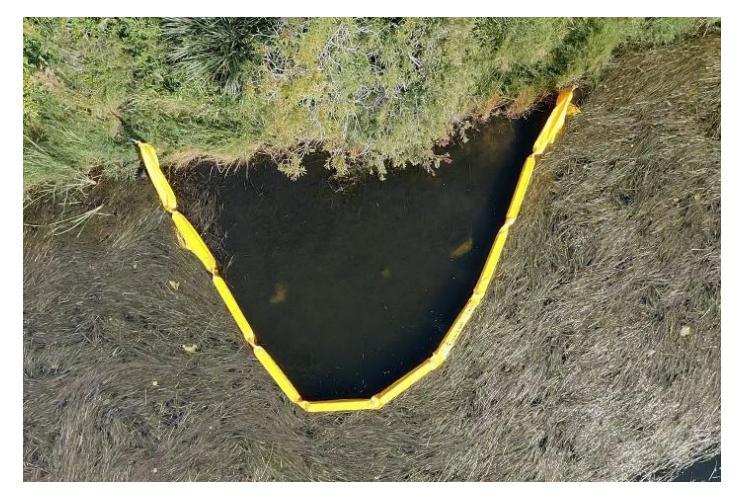
After

Results: Approximately 95%-98% (BEST GUESS) of the floating tape grass had sunk to the bottom, leaving the surface clear of almost all plant material in the experimental plot. All floating material remained unchanged in the control plot. Water samples taken inside corralled area and just outside of the sedimentation barrier for both Experimental and Control areas.

Setup: 50 foot turbidity barriers deployed in half circles along shoreline. Diameter 25 ft. One experimental, one control. Water samples taken inside corralled area and just outside of the sedimentation barrier for both Experimental and Control areas.

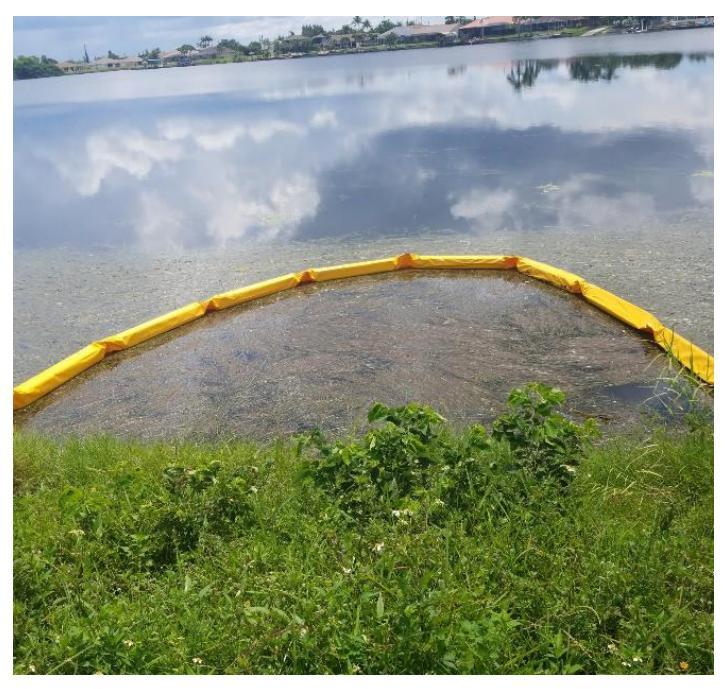
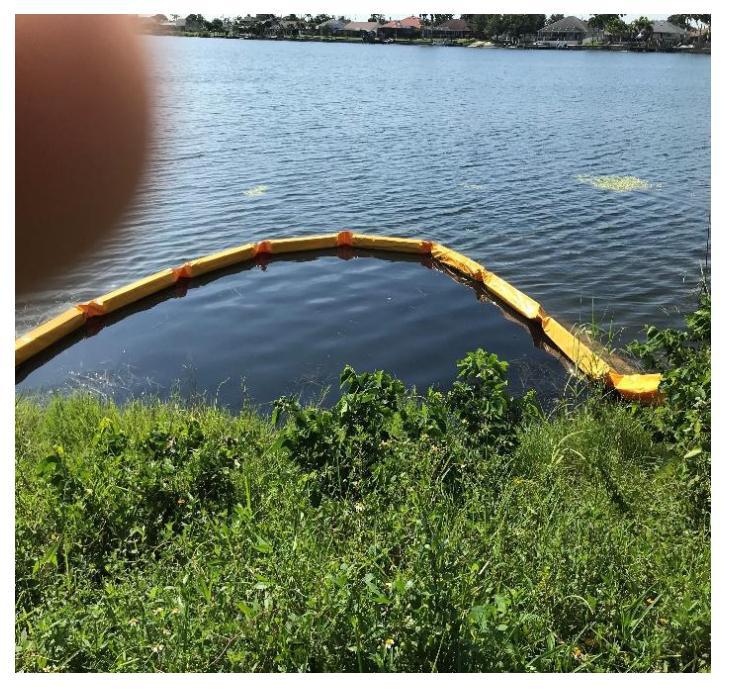
After

Results: Almost all floating tape grass had dropped out within 3 days. Surface was clear of plant material and water was clear enough to see the tape grass on the bottom of the corral. All floating material remained unchanged in the control plot.

Setup: 50 foot turbidity barriers deployed in half circles along shoreline. Diameter 25 ft. One experimental, one control. Water samples taken inside corralled area and just outside of the sedimentation barrier for both Experimental and Control areas.

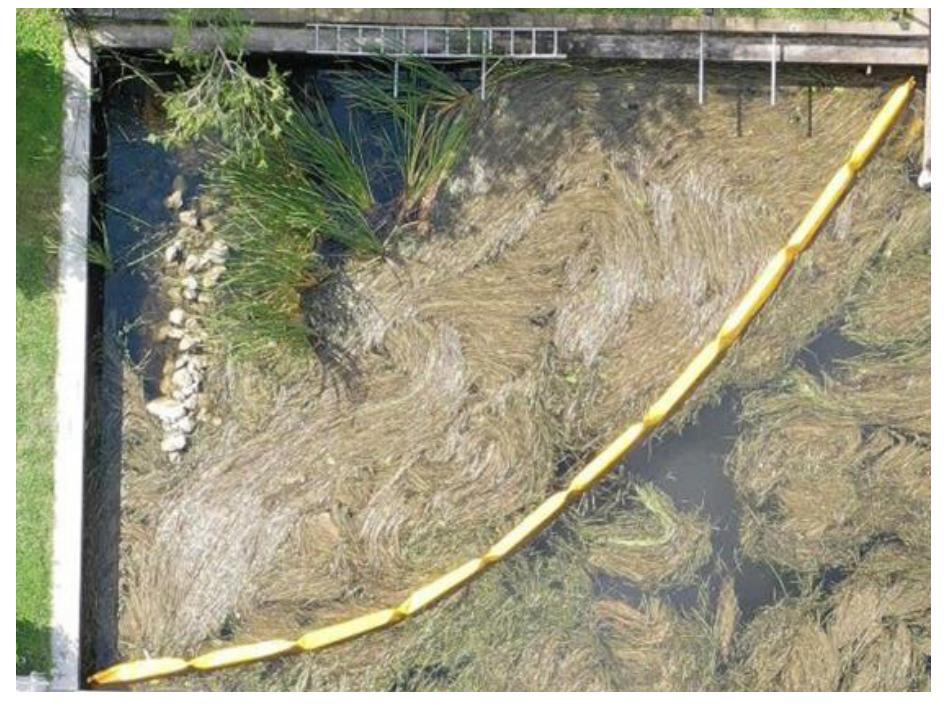
Before

Setup: One 50 foot turbidity barrier was deployed across the corner of a canal intersection creating a triangle with seawall on 2 sides. Posts were hammered into the ground close to the seawall to create sealed ends so that plant material cannot move in or out of the experimental area.

Results: No immediate change was seen. After a week of no change a second application at the same rate of Pondzilla was performed. After another week, approimatly 60% of the plant material remain in the roped off area. A third application was performed with the mixture in experiment 2 and all remaining plant material dropped out within 2 days.
